CHESTER CYCLING CAMPAIGN

CCC report on A56 Corridor

This note essentially covers the A56 from the 'SuperTrees' roundabout to the M56 roundabout. We note the wider area to be covered in the Mott MacDonald/ Broadway Malyan study and some observations will be made that are outside the immediate A56 corridor but within their kite-shaped area. We will address at least some of the issues in other parts of the 'kite' in later iterations of this note.

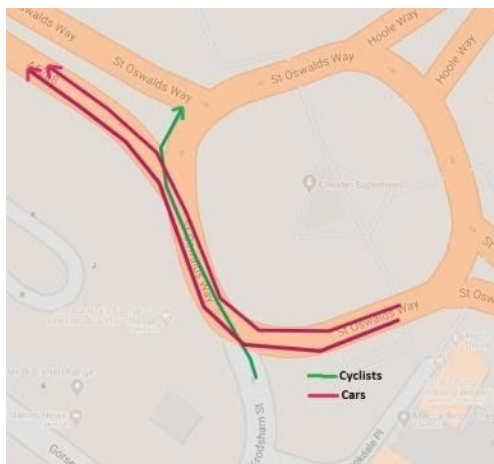
1. The A56 Hoole Way from the 'SuperTrees' gateway roundabout to the traffic lights at Black Diamond St.

This is fundamentally unsafe for cyclists. Specifically, if travelling from Frodsham St., there is a requirement to cross two traffic lanes which may not be understood by motorists travelling up to the Fountains Roundabout:-

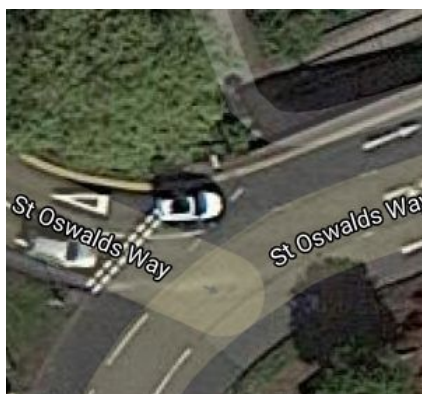
There is also danger from motors travelling down from the Fountains roundabout and then up Hoole Way (see position of white car in picture below) – many do not think that they should give way to (or even see) a cyclist who is already on the roundabout in the nearside lane.

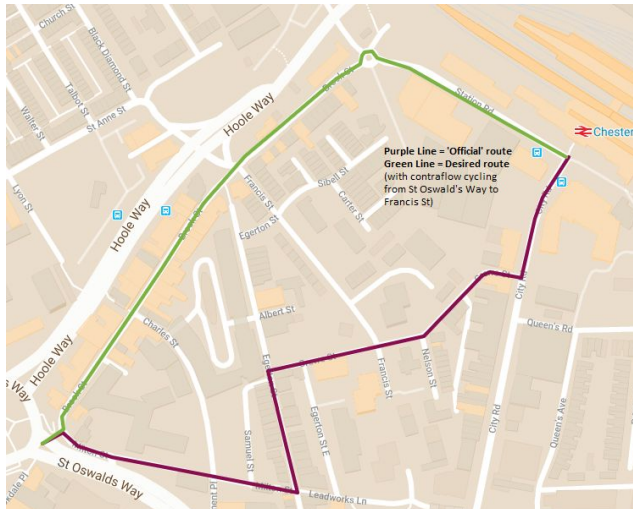
Whilst there is a reasonable crossing from Brookdale Place to Brook St, the 'town end' of this street is currently one way for all traffic. Cyclists leaving the City technically have to divert via Mill Rd and Egerton St in order to access the Black Diamond St traffic lights and Hoole Bridge (see picture). It is a longer route and not obvious although it is signed. Because of speed bumps and carriageway pinch point constrictions, these streets are neither particularly safe nor pleasant to cycle:-

The solution should be to make the 'town end' of Brook St (i.e. from St Oswald's Way to Francis St) two-way for cycles. The pavement is wide enough at the end nearest St Oswald's Way for a (segregated) Shared Use Path (SUP)*, but there would be a need to widen the path on the lower part down to Francis St and to restrict parking to only the east side of the road. Though illegal, people do currently stop and park on the west side pavement on this stretch and some element of prevention would need to be designed-in here.

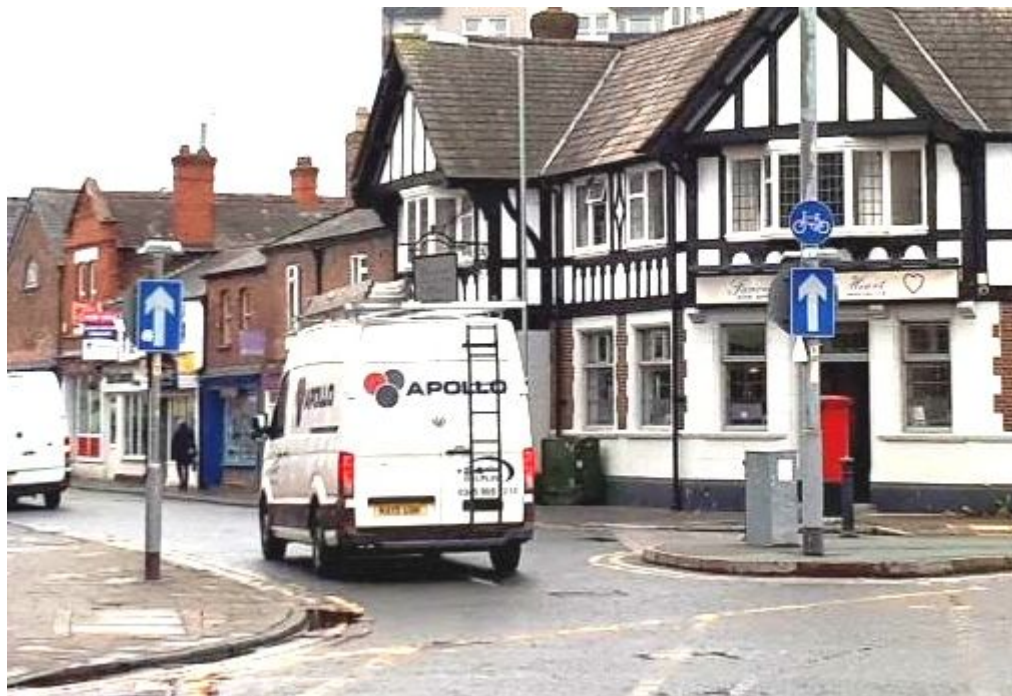
- a. The signage at the bottom of the street is non-compliant and the signs are mutually exclusive.

The round sign is one indicating cycles only. It should be rectangular if the intention is to allow the use of the road by motorised traffic as well.

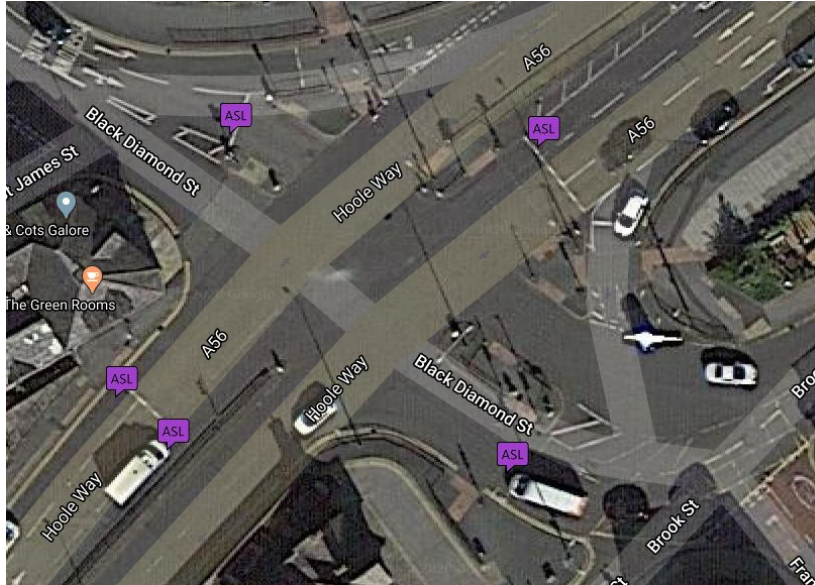
- b. An Advanced Stop Line (ASL) is required for cyclists cycling from the east side of Black Diamond St onto Hoole Bridge, given the width of the junction and the rise onto the bridge. ASLs should also be considered at the other points indicated:-

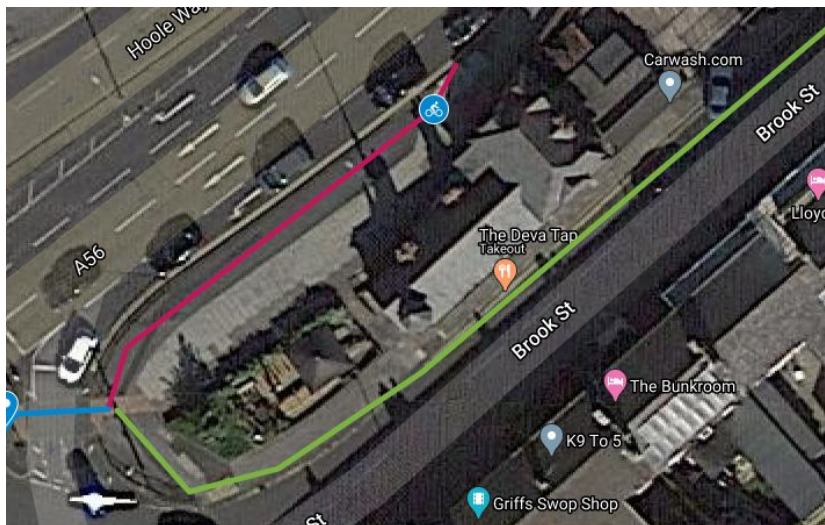
- c. There is a small section of cycle track on the city bound pavement to the lights (in Red in the picture):-

Ideally, it would also extend into the ‘Station end’ of Brook St (marked in Green) to at least the mini-roundabout to aid access to the station. The pavement in front of the car-wash and existing commercial properties is rather narrow – ideally, even if only when this area is redeveloped, the extra width could be acquired to facilitate this. Again, with ref to latest guidelines^{1,2}, a segregated track would be preferable if sufficient width could be provided.

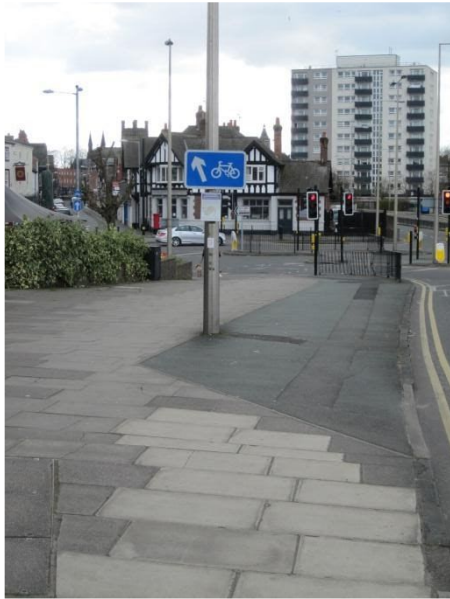
The 'start of cycle path' sign shown in the path above is pictured below:-

This is useful, but the ground should be marked to inform pedestrians using the pavement in both directions that it is shared use (or it could be segregated^{1,2} – it is wide enough - A simple line on the ground could be used to make the ride hand side cycle only.)

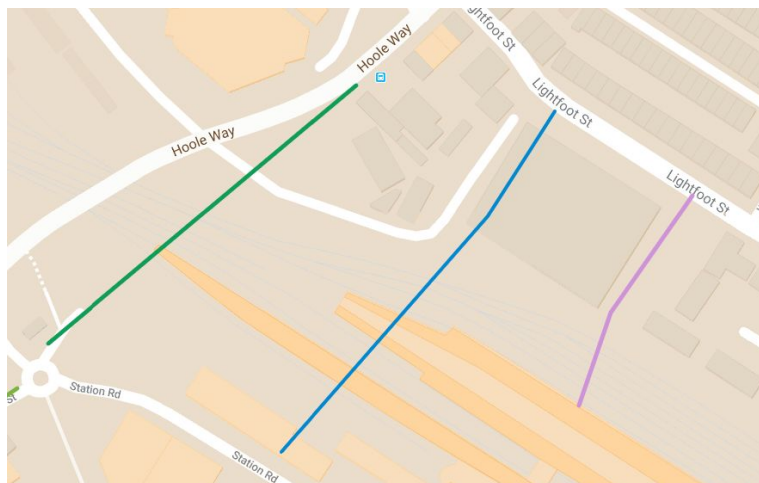
To some extent, the potential for improvements in this area depends on what arrangements are made for a new pedestrian/ cycle bridge over the Railway – preferably it would be constructed to run from the Bus stop area to the mini-roundabout (in green on map) but another route (e.g. the blue) might prove more feasible (Lightfoot St to Station Road):-

In addition a bridge from Lightfoot St to the existing station bridge (purple above) appears easy to realise in view of the proposed addition of new platforms in place of the existing sidings. If this could also be made cycle-able, this would aid passengers who intend to travel by train with cycles. We do not see this as a substitute for a route which will deliver non-train customer users to Station Road rather than to the track side of the station concourse. The green route above is the most direct and obvious one for cyclists and pedestrians.

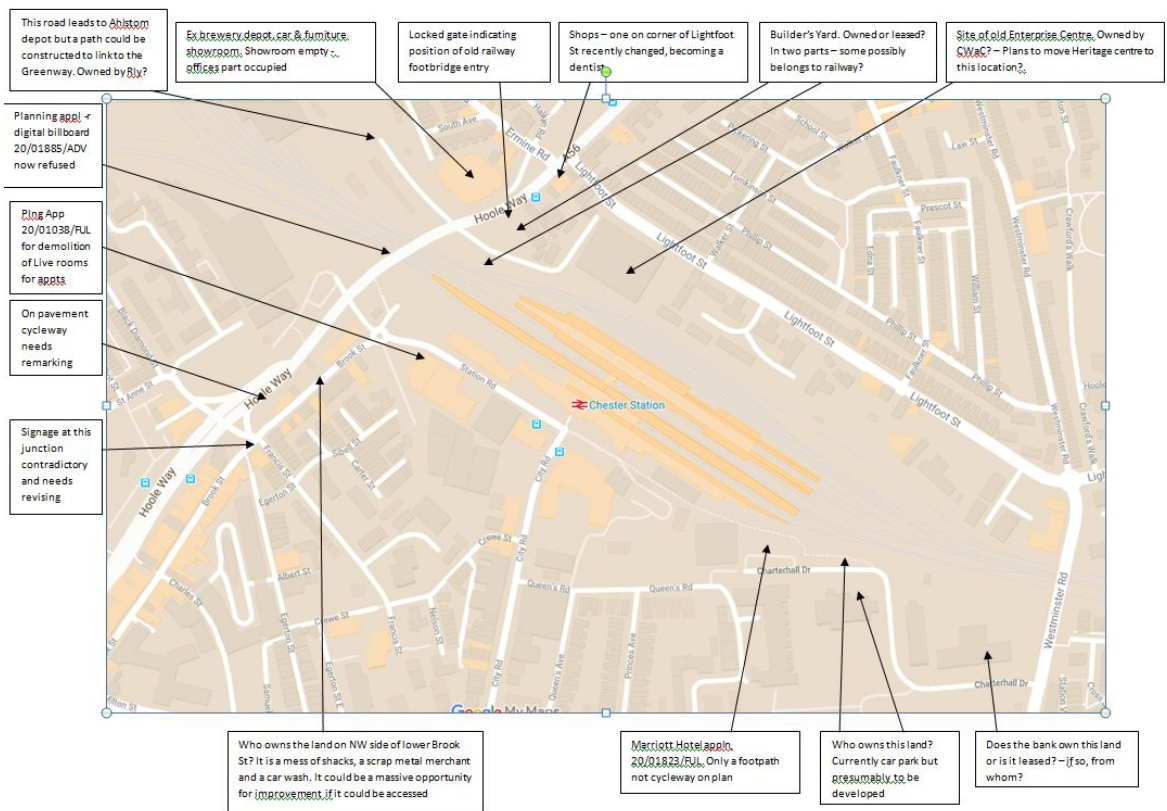
3. The Railway Station Area

This area has essentially been covered in separate discussions and documents with 5th Studio, but the overall issues can be summarised by this map:-

In the light of the latest Government Guidance^{1, 2} (27-July-20), the route between the Railway Station and Westminster Road should have segregated pedestrian and cycling tracks rather than be an SUP. A comment to this effect has been posted by CCC with respect to the Marriott Courtyard planning application (20/01823/FUL).

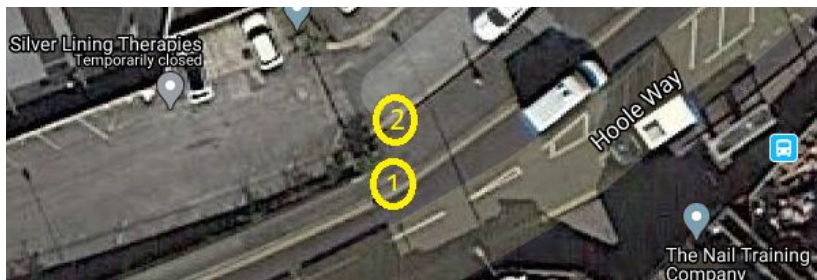
A minor improvement could be made by installing a dropped kerb in front of the vacant furniture warehouse. This would allow cyclists travelling from town to access Flookersbrook & Kilmorey Park Avenue more easily and safely and to avoid the Ermine Rd junction. The required dropped kerb is labelled "1". That marked "2" is already dropped.

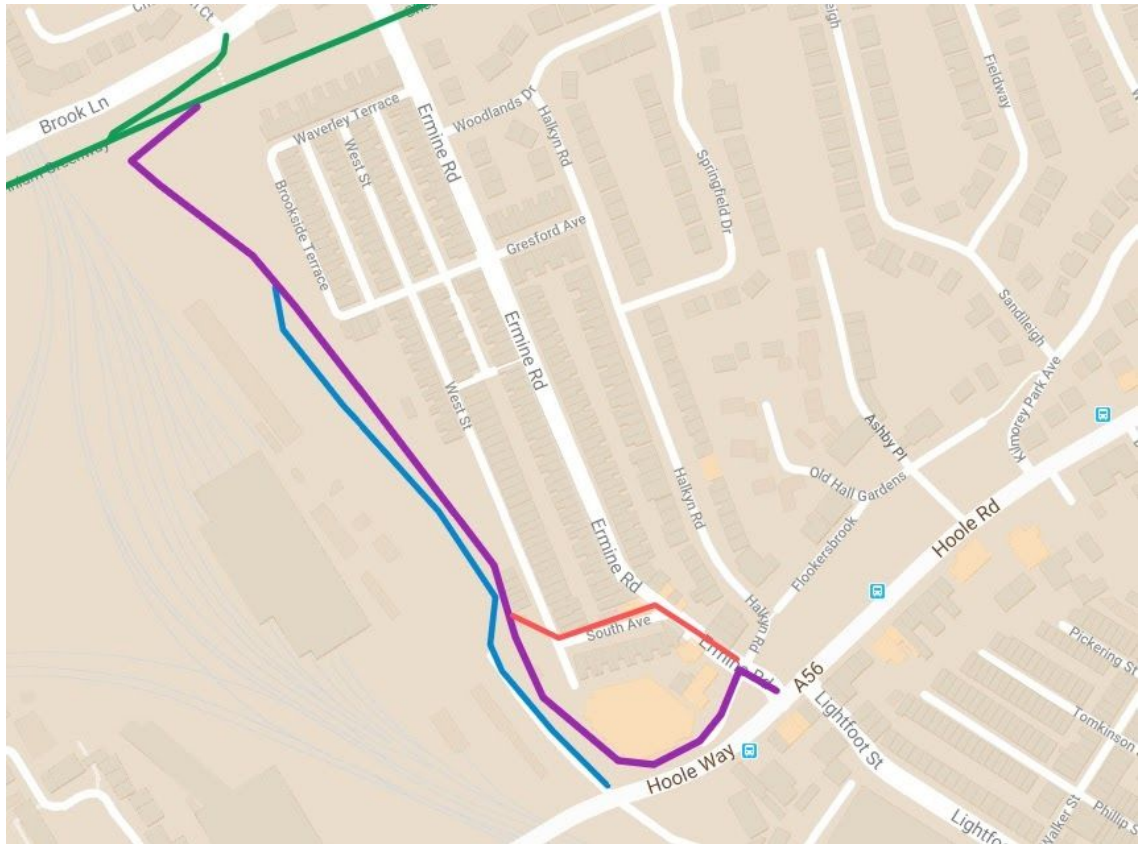
5. Cycle path A56 near Ermine Road junction to the Greenway

This is included in the Local Cycling and Walking Infrastructure Plan³ (LCWIP) report which has recently (July 2020) been adopted by the Council. The current route from the end of the bridge to the Greenway requires the use of Ermine Road and Brook Lane. Although a two way street, it is in effect a single carriageway due to parked cars leading to traffic queuing awaiting an opportunity to pass. It is not a safe road for cyclists. There is more than adequate space to build a segregated footpath/cycleway on the unused land behind the houses on West St. Access would be possible either from the Alstom lane off the bridge (blue in the picture below) or, preferably, from the side of the vacant warehouse (purple). A third, less satisfactory, option would be to access the land via Ermine Road and South Avenue (orange). In all cases, it should be noted that the Greenway runs above the level of the unused land and the path would need to be ramped up to provide access to it. Whilst a kinked ramp up to the Greenway is shown below, a straight ramp may be an easier alternative.

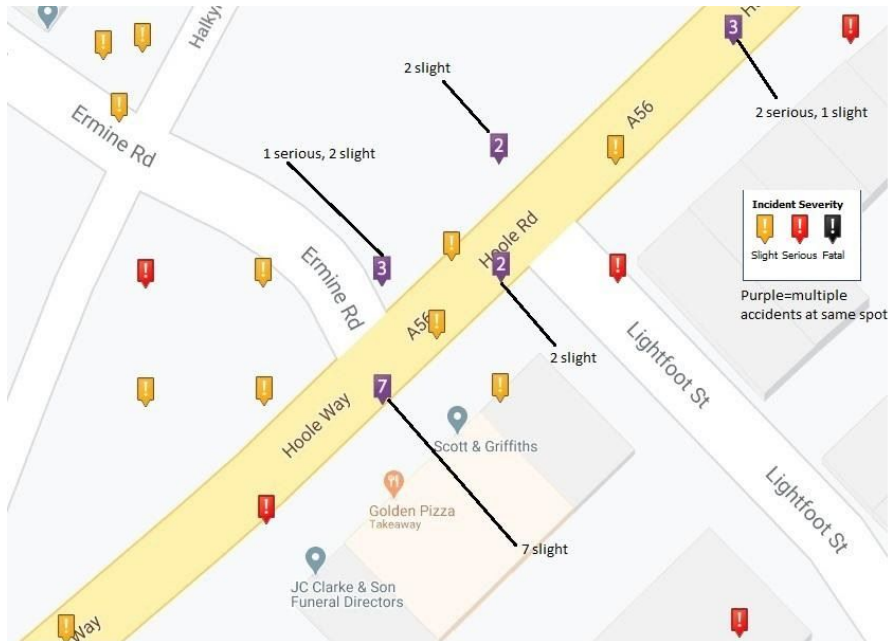
6. A56/Ermine Road/ Lightfoot St junction.

This is a dangerous and unpleasant junction with an unenviable accident record for it and the immediate vicinity (over 1/year over the last 21 years, including some serious). Note that this DfT data⁴ only includes incidents which have been reported to the police and in which someone suffered injury. The reality is that there are many more incidents.

This junction needs a radical makeover and consideration might be reasonably given to a traffic light controlled ‘CYCLOPS’ junction (or ‘Dutch roundabout’) at this point if space and land ownership permits. For more information, there is a CYCLOPS animation at:-

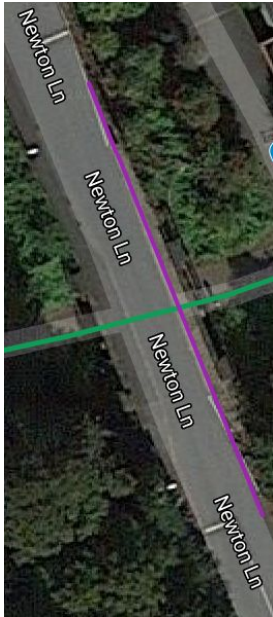
9. Newton Lane Bridge

For cyclists travelling towards Hoole Road, the traffic lights can present some difficulty when having to make a start from ‘red’, owing to the rise over the bridge. The possibility of installing a one-way bypass to allow cyclists to avoid the stop is a potential solution to this problem (represented in purple in picture).

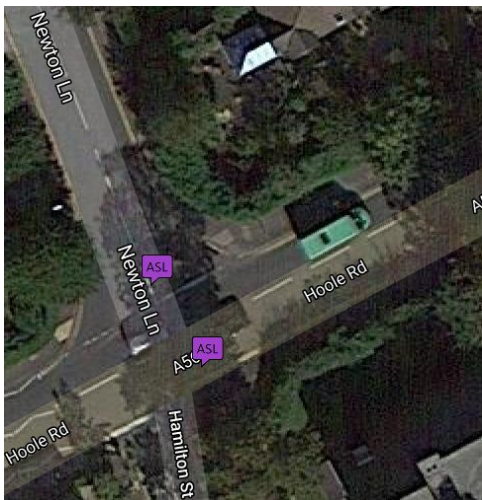
10. Junction of Newton Lane with Hoole Road

Whether or not traffic signals or another system (eg Dutch roundabout) are considered for this junction, an ASL at this point would aid cyclists wishing to turn right towards the town (and probably reduce pavement riding by those using the pavement to get to the pedestrian lights in order to cross the road). An ASL for those turning right from Hoole Rd into Newton Lane would also be beneficial. It is worth noting that this junction is an important link on the crucial route from the Greenway to the canal path (via Hamilton St - Crawford's Walk – Westminster Rd Bridge). Any re-configuration of this junction needs to take into account the pedestrian lights on Hoole Rd just to the SE of it.

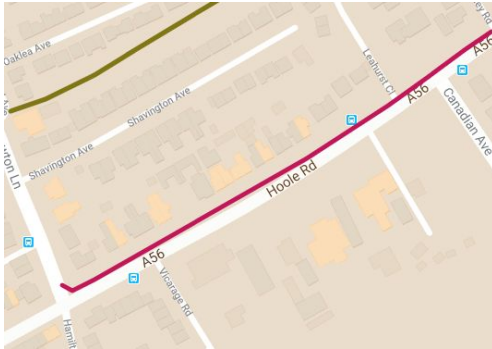
11. Cyclepath from Newton Lane to Knowsley Road

This SUP was a ‘de minimis’ installation on an already existing wide footpath. It is inadequately signed and, as such, few know where it officially starts and ends (in red in picture):-

The sign at the Newton Lane end is obscured by trees and there are no ground markings to indicate to pedestrians that it is an SUP. There are also some problems of car parking on the footway – again something that could be alleviated by ground markings. The width is sufficient to have segregation between cyclists and pedestrians, which would conform to the latest government advice^{1,2}.

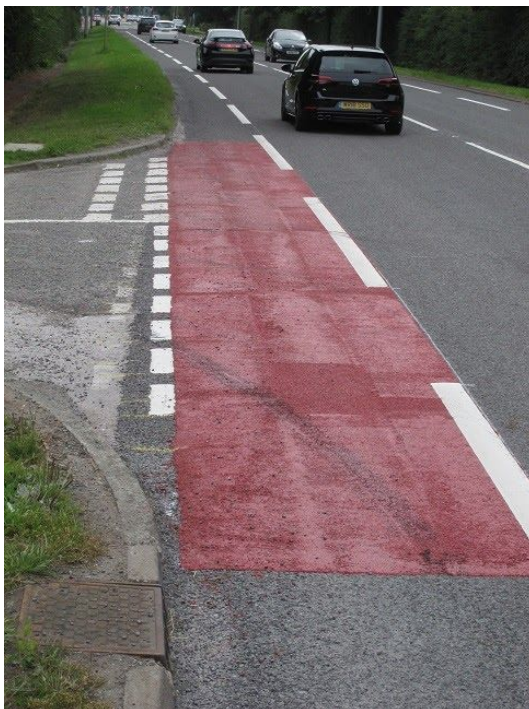
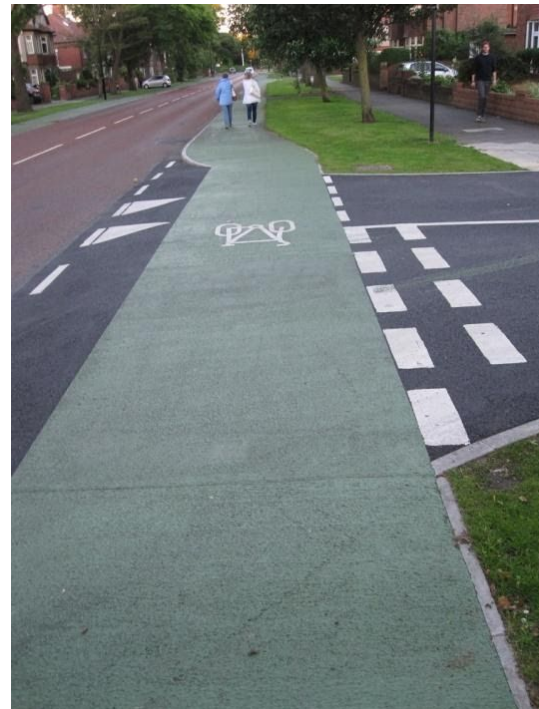
12. Junction of Cyclepath with Leahurst Close

The junction from this cul-de-sac can be obscured by trees. It needs marking to give the cycleway unambiguous priority as per the examples below (the first for a cycle lane has recently been installed on the A41, the second is for an SUP):--

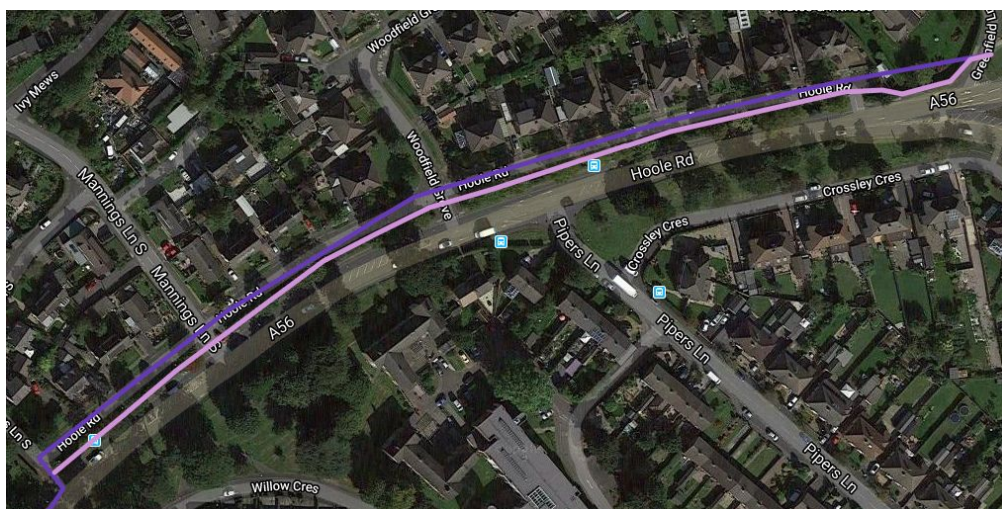
17. Mannings Lane S/'old' Hoole Road access point to Greenfield Lane

There are a couple of options here:- If the cycleway had been extended to this point (or if not, a dropped kerb from the main carriageway could provide access), then the existing 'old' Hoole Road could be used (with the installation of a small length of track at the end) to provide access to Greenfield Lane (purple in picture). An alternative may be to run a new path along the verge preferably on the west side of the existing hedge if there is room (in pink). There may be a need to relocate the hedge as has been done in Sutton Lane in Ellesmere Port.

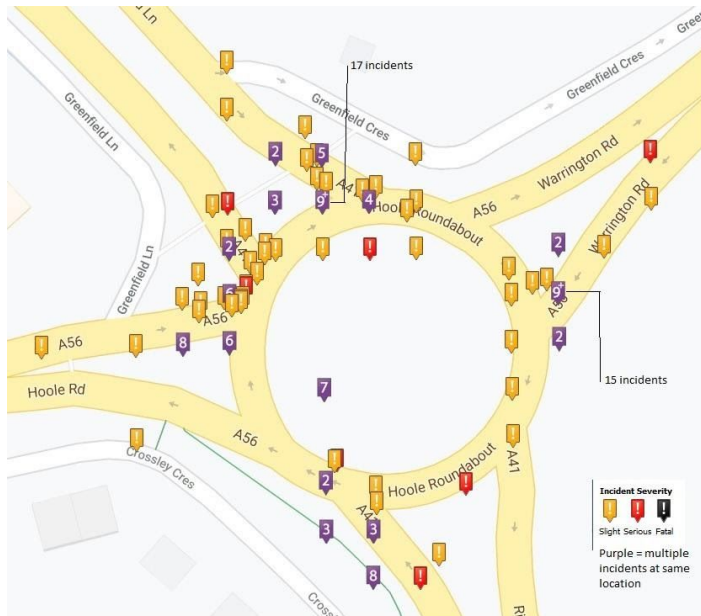
19. Hoole Road Roundabout (A56/A41)

This needs a complete and bold re-think. It is dangerous for cyclists and pedestrians and there have been numerous car accidents. As the picture shows, there have been many accidents over the past 21 years³:-

It can become almost impossible to cross (even for cars) at peak periods. Crossing on the west side is particularly important for pupils from south of the roundabout attending Upton school.

A solution more favourable to sustainable means of travel should be the objective and any solution must also address the issues at the Green Lane/A41/ Guilden Sutton Lane junction – see pp 27 below. The Hilton Double Tree Hotel is difficult to access from the NW side of the road for non-motorists and this difficulty needs to be factored into any new arrangement.

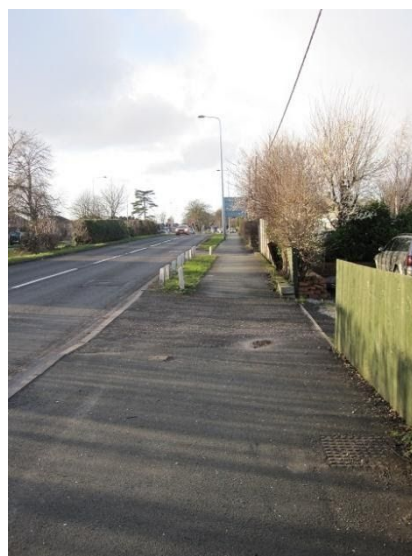
20. SUP / Cycle Lane- from Greenfield Crescent to Mannings Lane

The recent (July 2020) installation of a 2m wide cycle lane from Mannings Lane to the roundabout will have undoubtedly made this stretch much safer for cyclists travelling SE. There is still a need for a dropped kerb at the top of the Greenway ramp to allow access to and egress from this new cycle lane (to be checked - may be OK?).

Longer term there might still be an argument for a segregated path or SUP for the full distance along the NE side of the A41 for this stretch, which would facilitate cyclists travelling NW to the Greenway or to Mannings Lane.

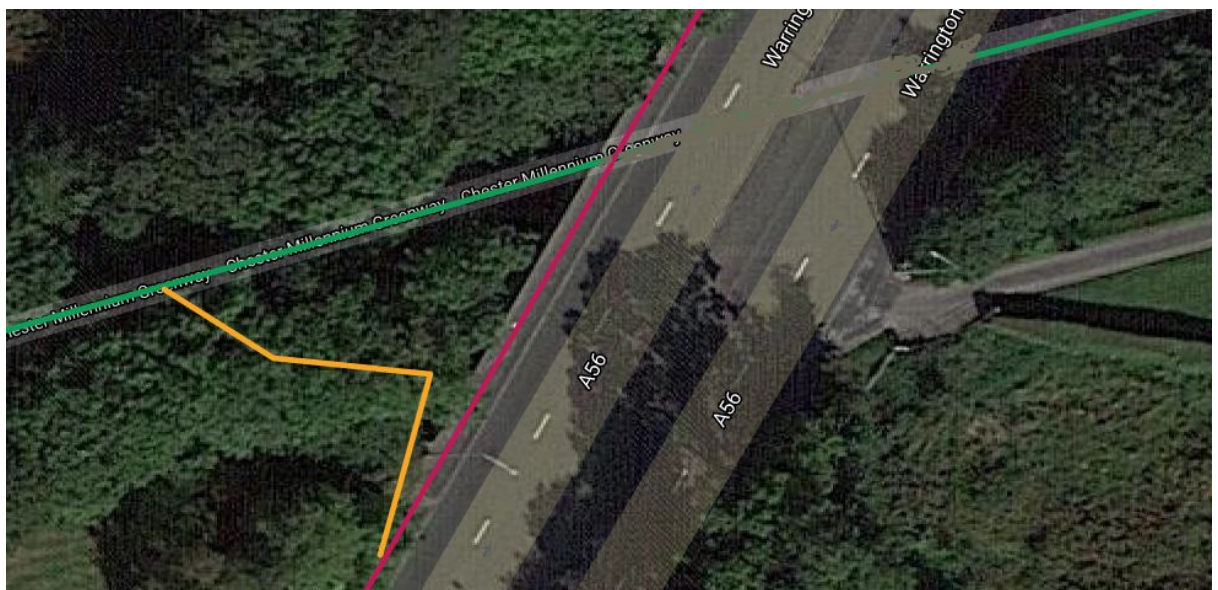
22. Hoole Rd/A41 roundabout to A56/M53 Roundabout.

There is a cycle path along the pavement here. Some vegetation needs attention and possibly the surface too. Access to the Greenway at this point might usefully be incorporated from this path as per picture (switchback shown as there is a difference in level, but route could be varied and shortened):-

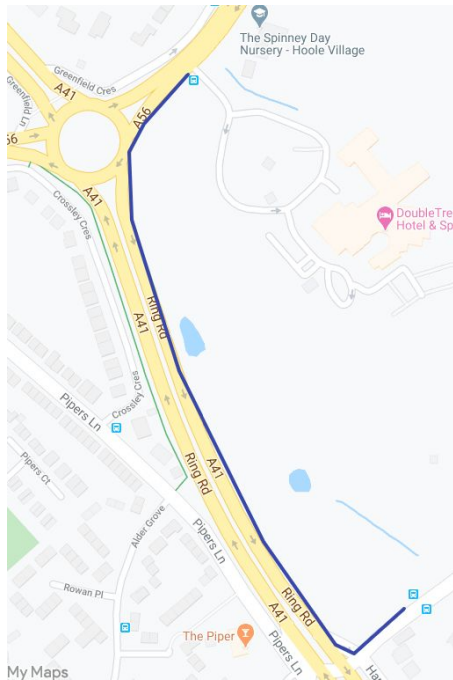
The carriageway here is dangerous as motorists exiting Warrington Road to travel on the A41 South are usually looking to their right for oncoming cars rather than to their left for cyclists on the main road or pedestrians crossing. There is a current wide footpath here which could easily be signed and utilised as an SUP, or widened to have a segregated path

but there is no proper entry to it from the road and Police currently often park blocking it in order to observe the roundabout.

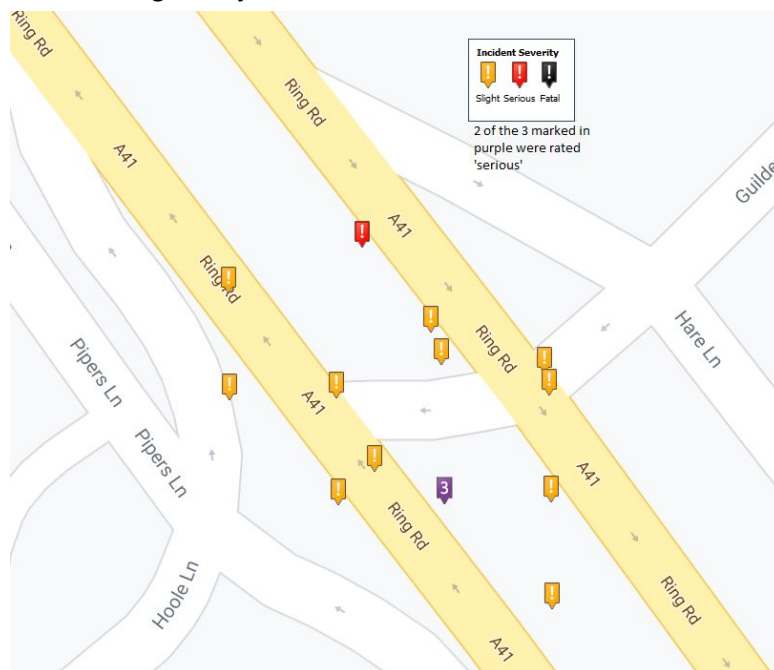
27. The A41 Junction with Hoole Lane and Guilden Sutton Lane

This is a dangerous junction and difficult to cross:-

Again, these are DfT records³ from the last 21 years but only include those incidents reported to the police and resulting in injury. The junction needs a complete re-think in association with revisions to the Hoole Road roundabout. Radical options such as a ‘Cyclops’ crossing or a Dutch style roundabout should be examined. To reiterate, any changes here should be done in tandem with those for the roundabout itself – see pp 19 above.

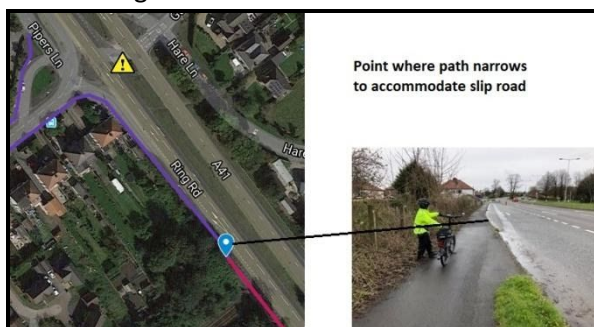
28. Hoole Lane junction to A41 (W side) cyclepath

The generally very good A41 SUP on the west side narrows to accommodate the carriageway slip road from the A41 to Hoole Lane. It is also not signed as a cycle lane from Hoole Lane. This needs modification as part of the overall re-design to maintain an adequate width for the full length.

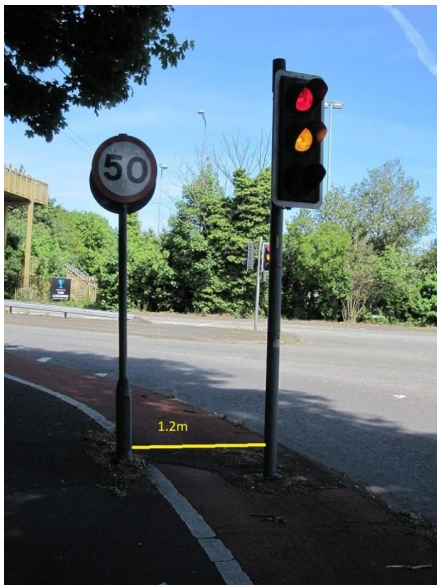
This same small island is possibly the intended route for those coming up Plas Newton Lane and wishing to turn right to travel SE on the A41. All the points about deficiencies made above apply equally for this turn and in addition, the cyclist is then confronted with having to cross two lanes of potentially moving traffic to access cycle lane.

If such a routing was the original intention, it is not signed from Plas Newton Lane and would not be obvious or instinctive. In addition, there is only a 1.2m gap between the traffic light pole and the speed sign (DfT minimum recommended 1.5m). These problems may not be addressed in the current refurbishment but should be considered in any future work..

Again, the most acceptable solution would be an ASL with a feeder lane. The turn is on a slight hill and this crossing can be intimidating as there may be cars on the left hand side waiting for the lights to change to allow them to access Plas Newton Lane.

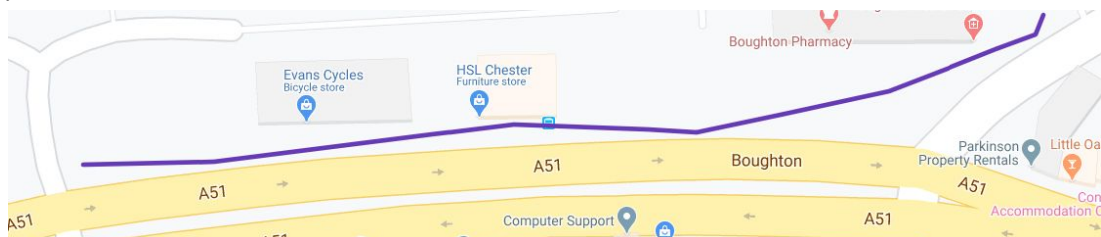
C. A51 Boughton

Work is currently being progressed on this section - clearly more than a temporary change in response to COVID as a significant portion of the existing pavement has been removed. It is unclear as to whether the cycle path will be a carriageway lane or a raised kerb level track. Either way, it should be an improvement on the present situation and should be made permanent.

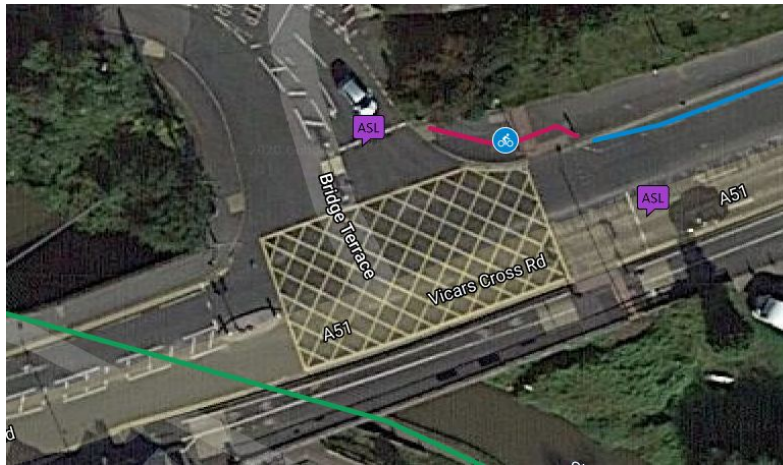
Some deficiencies in the current configuration are noted below for the record but may have already been addressed as part of the above work:- Whilst there is a cycle bypass in-bound for the city cyclists, there is a need for an ASL for those wishing to turn right to Aldi and the other stores. There is also a need for an ASL for cyclists exiting the estate and turning right towards town, as the road is on a slope which necessitates extra time for cycles..

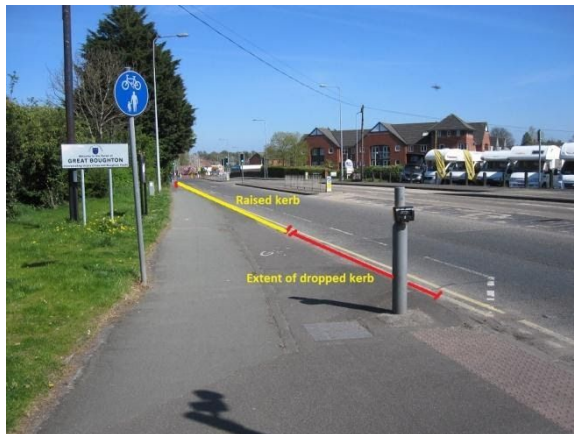
There is an existing stretch of pavement SUP, the signage for which is currently confusing as it is not clearly marked that it ends as soon as it is round the corner. The sign, which presumably is for motorists' information, may be misread by cyclists as an indication that it continues on the pavement despite the adjacent carriageway lane:-

It needs markings on the ground. It is expected that the 5 Parishes report will endorse the concept of a continuous cycleway from here to the A41.

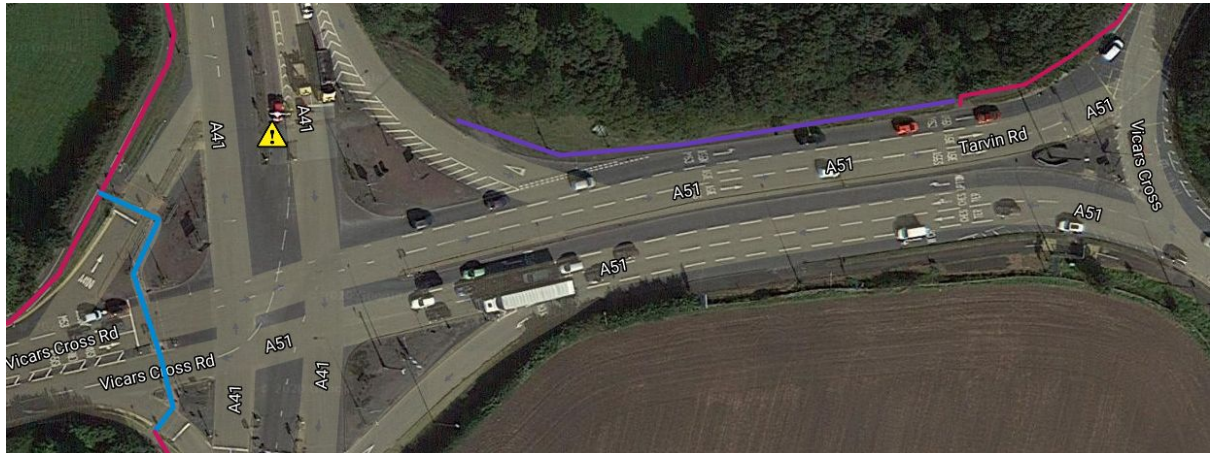
F. A51 between A41 and A55

There is a need for a safe pedestrian/cycle crossing from the existing western SUP (in red) to the eastern side of the road (at the point with the hazard sign).

There is also a clear need to convert the footpath shown below in purple into a formal SUP to link with that (in red) which goes to the A55 roundabout.

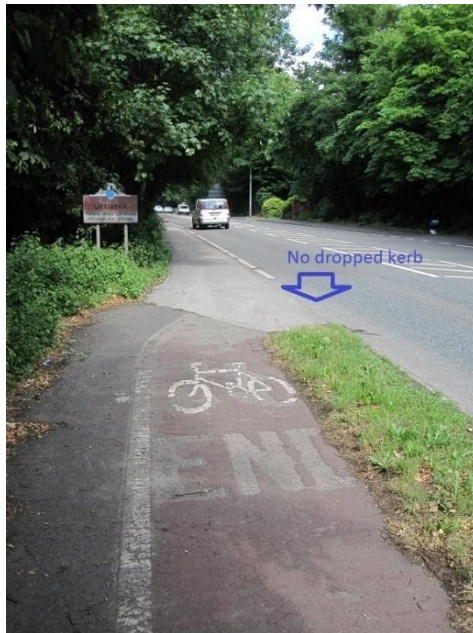
The existing cycle lane (red) ends without a dropped kerb to enable rejoining the carriageway.

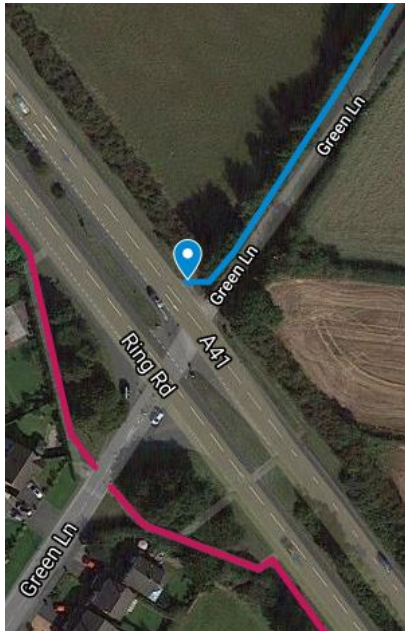
H. Green Lane – A41 junction

This is horrendously unsafe to cross if travelling NW unless one knows about the crossing point some distance to the south (even then, not safe or pleasant) – it is not obvious.

The state of the cycle contra-flow lane is currently (July 20) dreadful and unusable from overhanging branches and hedges (they have been reported)
