CHESTER CYCLING CAMPAIGN

CCC report on A56 Corridor

This note essentially covers the A56 from the 'SuperTrees' roundabout to the M56 roundabout. We note the wider area to be covered in the Mott MacDonald/ Broadway Malyan study and some observations will be made that are outside the immediate A56 corridor but within their kite-shaped area. We will address at least some of the issues in other parts of the 'kite' in later iterations of this note.

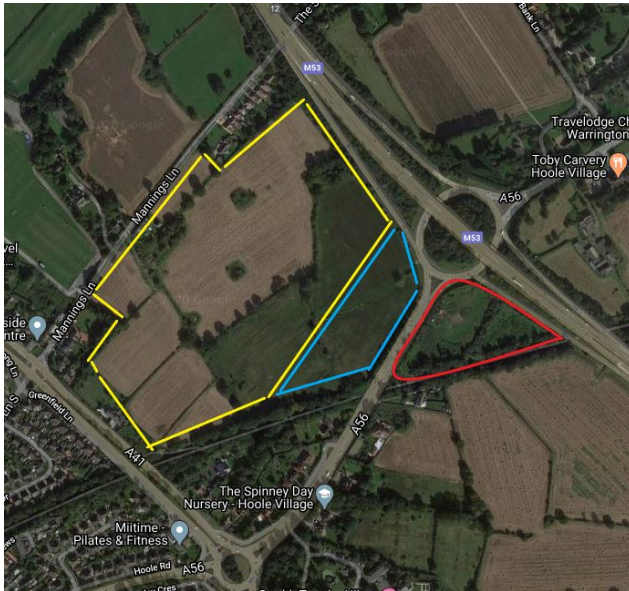
In the picture below, this land 'on the other side' is outlined in red which is about the same size as the Upton P&R site. The original documents regarding this proposed development are vague regarding the areas allocated for P&R vs housing, but along the lines of the area in

blue for the P&R in exchange for permission to build on the Greenbelt area bounded in yellow.

It should be noted that the latest study (from 2015) for a P&R at this point concluded that there was “no current business case for the additional facility”⁵. It should also be noted that there is very poor signage (and no indication of free spaces) for travellers from the M53/A56 to the existing P&Rs at the Zoo and Wrexham Road which leads to under-utilisation of the existing infrastructure.

Were a P&R facility to be installed, then Park & Cycle should be a major part of the offering. For this to work satisfactorily, the Millennium Greenway would need significant widening and segregating to accommodate the extra volume of cyclists.
